NASA TM X-64754

VAMISTOR RESISTOR INVESTIGATION

Quality and Reliability Assurance Laboratory

May 1, 1973

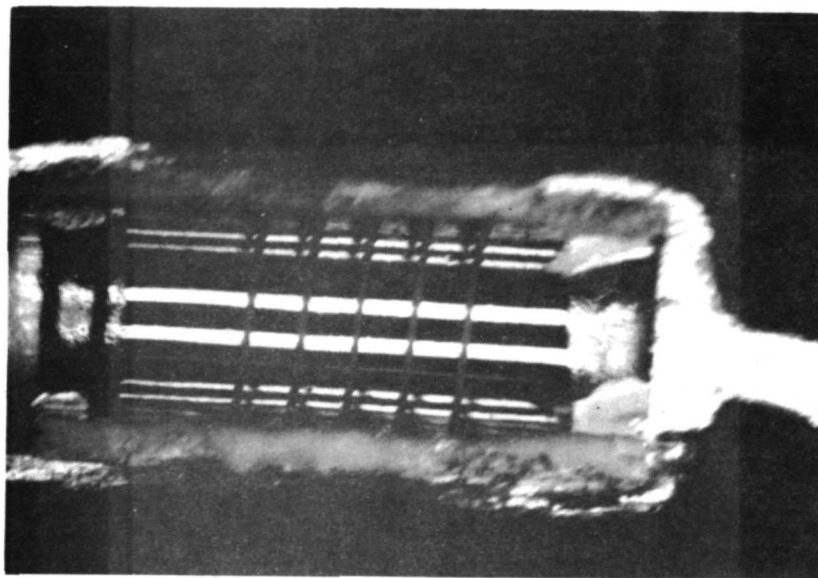
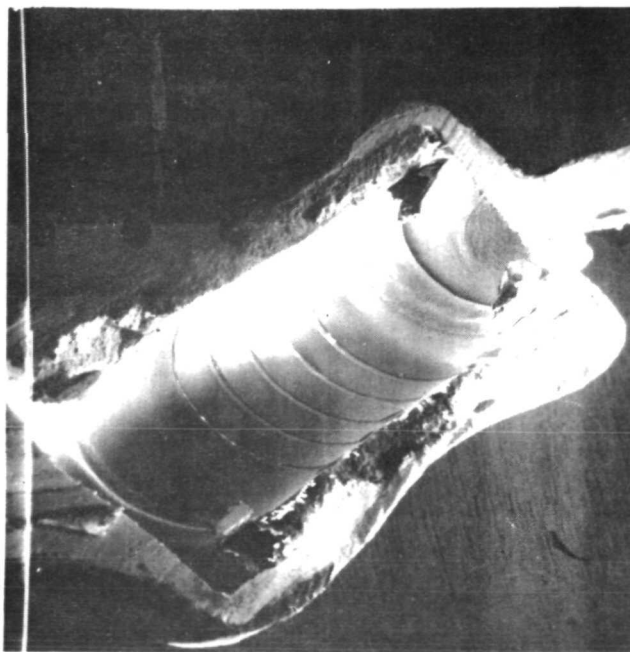
Figure 2. Photographs of Good Resistor, S/N 231.

NOTE: Shows metal film with spiral cuts.

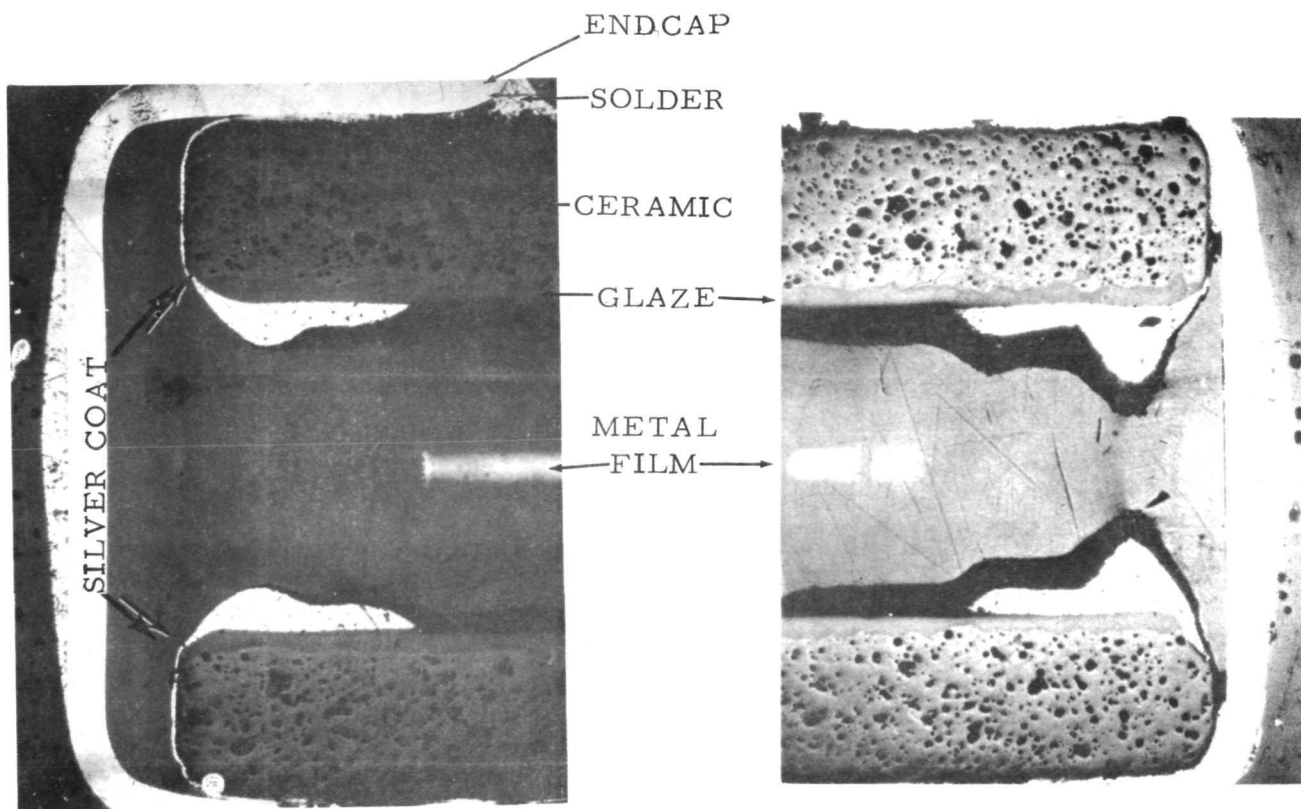
Figure 3. Cross Section of End Cap Regions of Good and Bad Resistors.

(1) Evaluation of Endcap Seal. Resistors cross sectioned to determine condition of the endcap seal are shown in figures 3 through 6. The silver applied to ends of the ceramic tube was generally of non-uniform coverage and displayed voids, particularly at the edge of the inner diameter (see figures 3 and 4). No failures could be attributed to this but it does indicate a lack of controls for the silvering process. The poor coverage could also allow moisture to penetrate into the pores of the ceramic where it would be difficult to remove during subsequent drying operations. The copper plating applied to the silver is shown on resistor S/N 125 in figure 5. The plating covers the silver on the outer diameter of the tube and extends to approximately one-half of the tube wall. A suspected defective hermetic seal of a bad resistor, S/N 219, is shown in figure 6. The solder has voids and is separated from the silver. Also evident is separation of the copper overplate from the silver. The use of a copper plate to improve solderability of the silver is of dubious value, because any mechanism/material which would hinder a metallurgical bond of solder to silver (a readily solderable material) would tend to prevent bonding of the copper plating to the silver as well. In this case the presence of the glass frit in the silver (used to bond the silver to ceramic by "firing") would reduce the solderability of silver and also, adherence of the copper plate.

NOTE: Arrows point to thin silver coating on end of tube.

Photo 1: 35X Good Resistor S/N 131

NOTE: Porosity of ceramic is similar in both resistors.

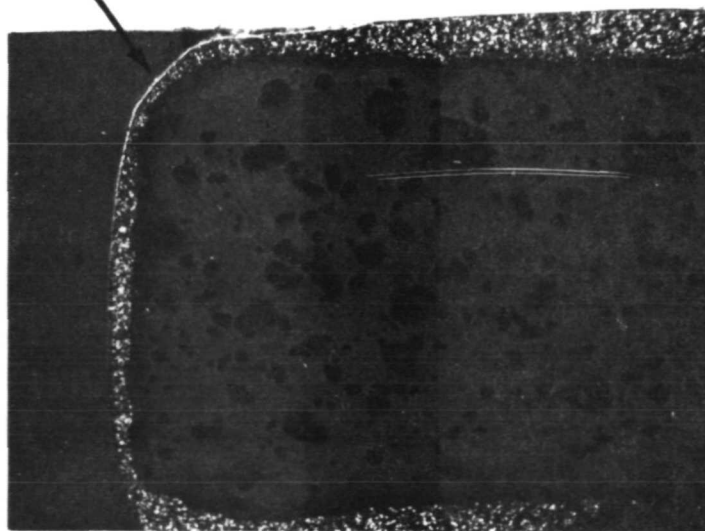
Figure 5. Copper Plating Over Silver on Ceramic Tube End of Resistor S/N 125 (Etched) 100X

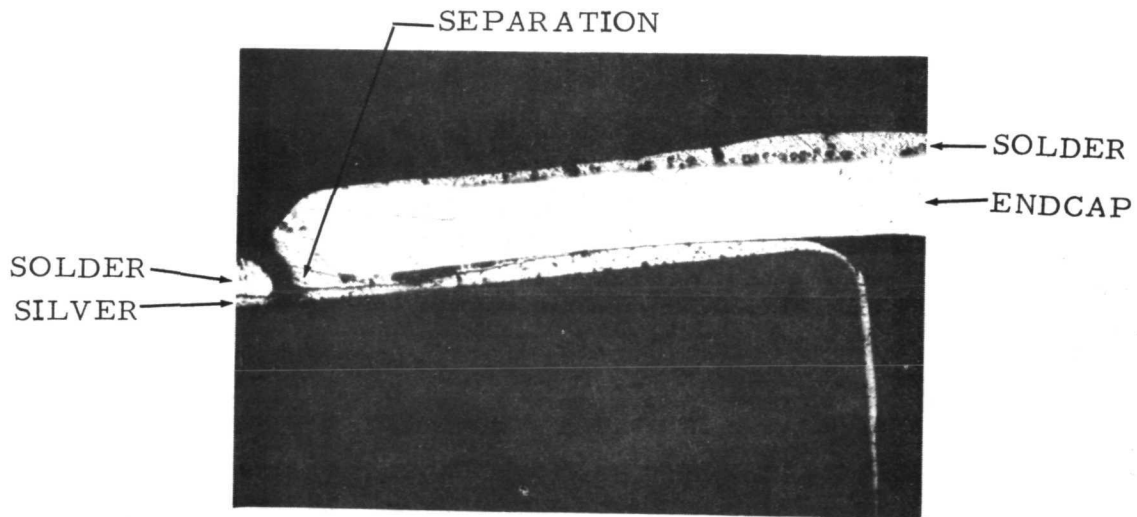
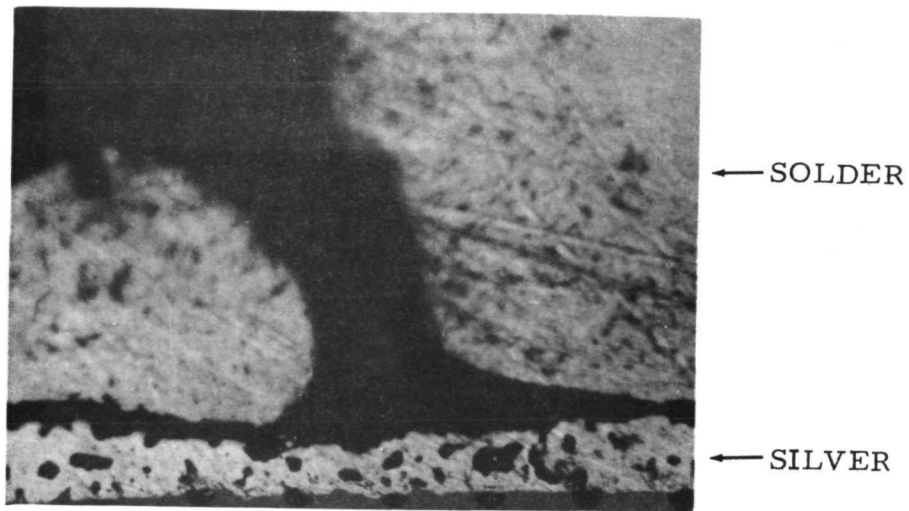
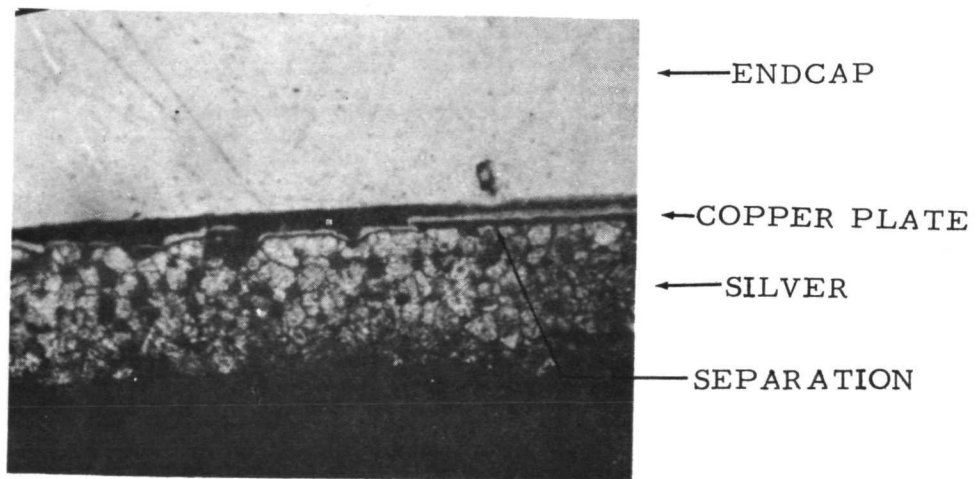
Figure 6. Endcap seal of Bad Resistor, S/N 219.

Photo 1: 75X Overall View

Photo 2: 500X Void in Solder and Separation (Arrow, Photo 1)

Photo 3: 500X Copper Plating Separation from Silver

NOTE: Photos show separation of solder and copper and void in solder fillet.

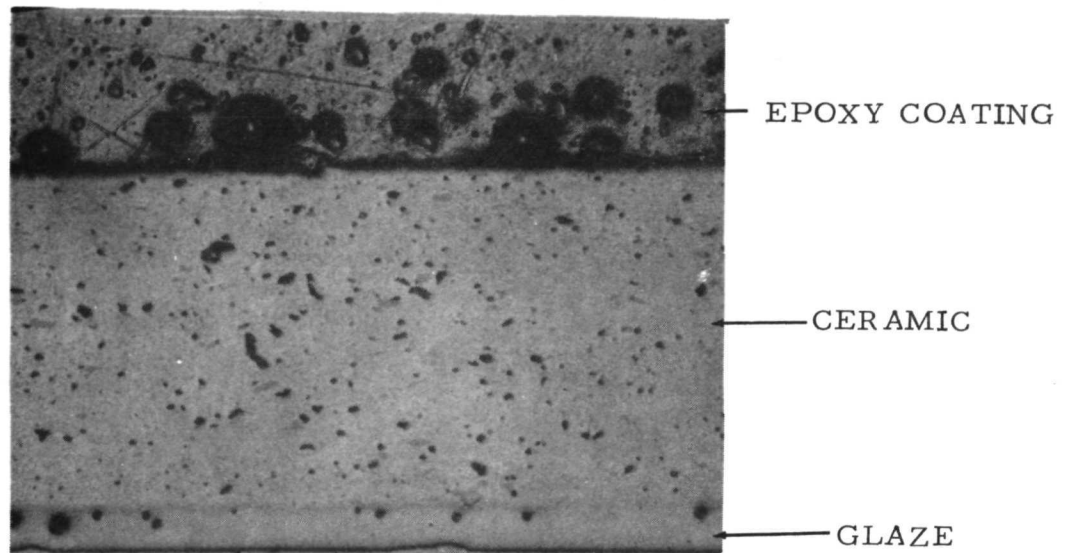
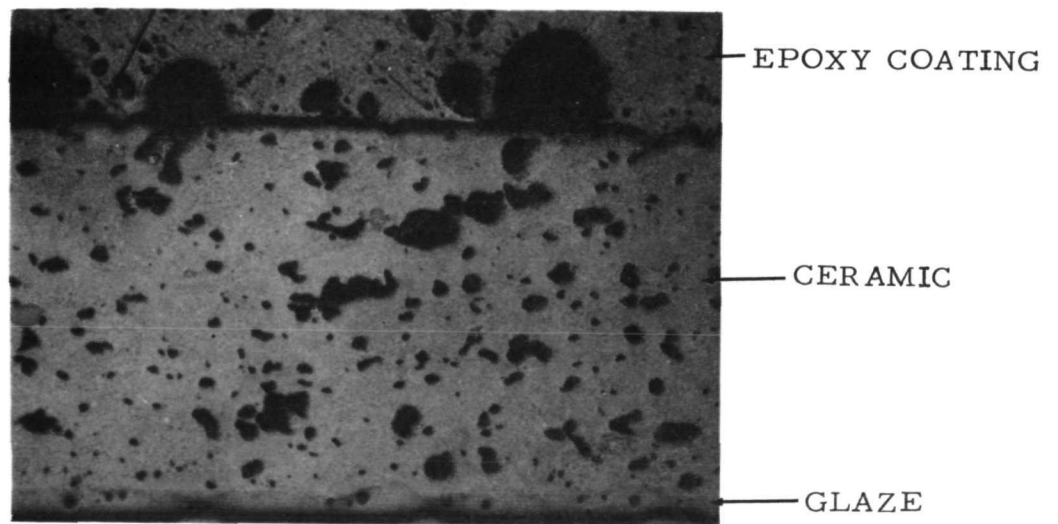
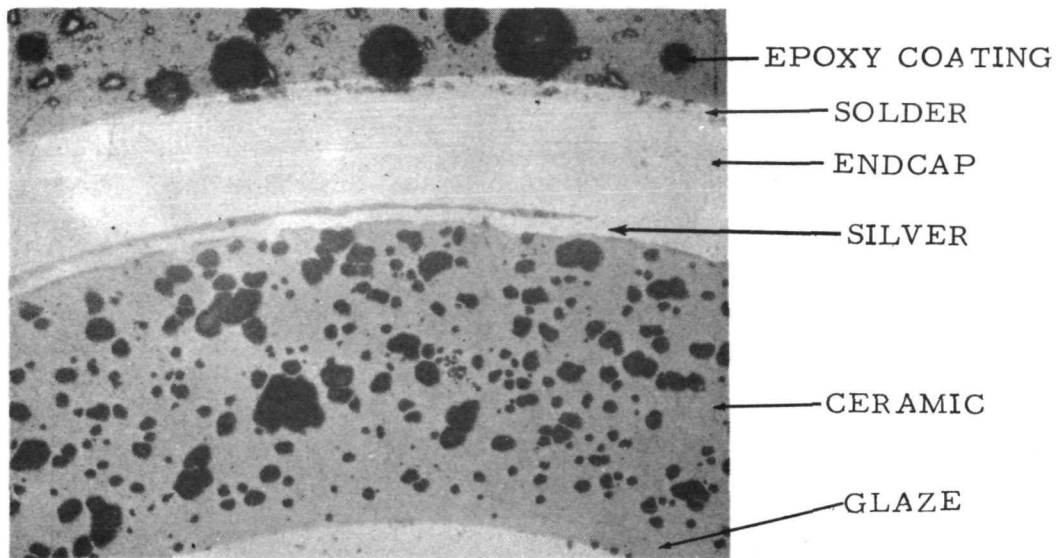
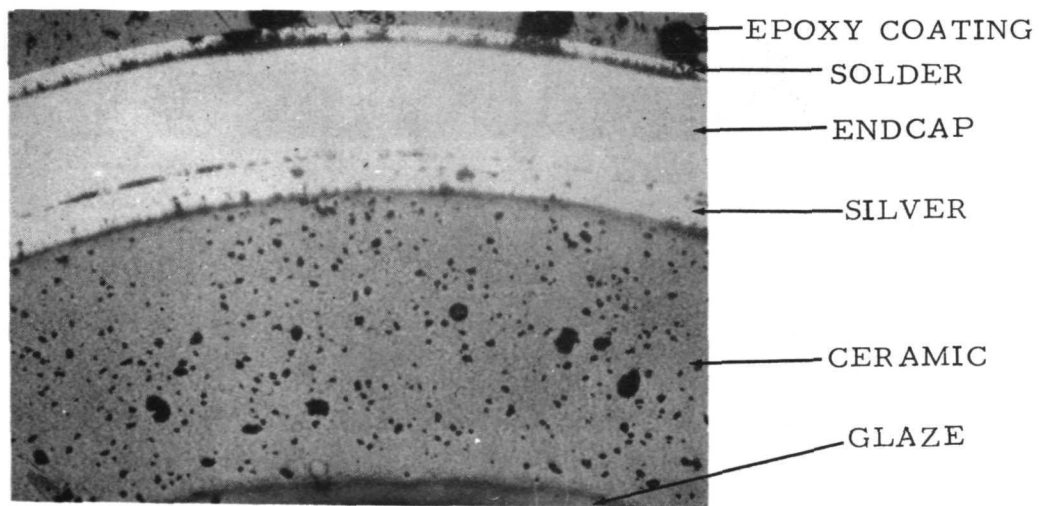
Figure 7. Comparison of Porosity of Good and Bad Resistors, (100X)
(Sheet 1 of 2)

(2) Evaluation of Porosity of Ceramic. The porosity of the ceramic (Steatite) tube was evaluated to determine if a correlation could be established between degree of porosity (number and size of pores) and condition of resistor (good or bad). Three resistors of each condition were cross sectioned in longitudinal or transverse directions to the resistor axis and photomicrographs were taken at the same magnification (100X) of the ceramic tube. As shown in figure 7, there is no apparent correlation between the two factors. For example, good resistor S/N 191 (photo 3) has as much or more porosity as bad resistor S/N 125 (photo 2); however, it can be assured, logically, that a resistor with greater porosity would hold or trap more moisture and cause a greater drift than one with less porosity, other circumstances being equal. The amount of moisture retained would also depend, to some extent, on the degree of interconnected porosity that allows moisture to permeate the ceramic.

Photo 1: Longitudinal Cross Section of Good Resistor S/N 220

Photo 2: Longitudinal Cross Section of Bad Resistor S/N 125

Photo 3: Transverse Cross Section of Good Resistor S/N 191

Photo 4: Transverse Cross Section of Bad Resistor S/N 58

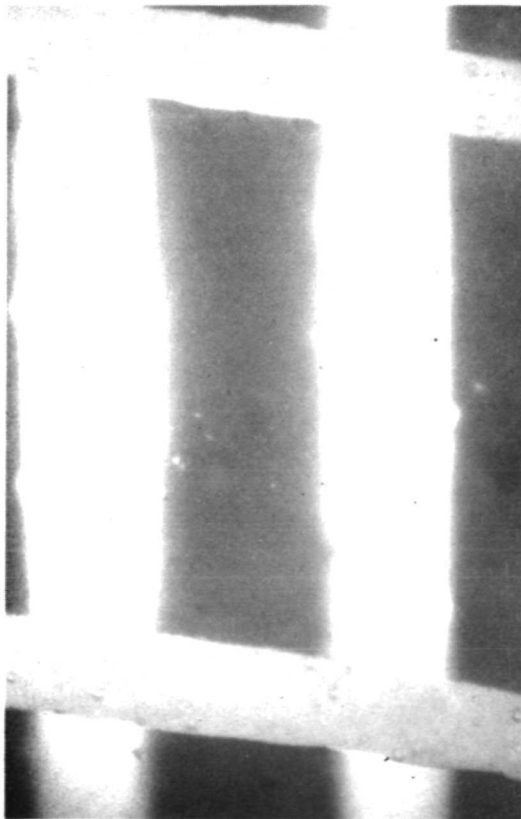
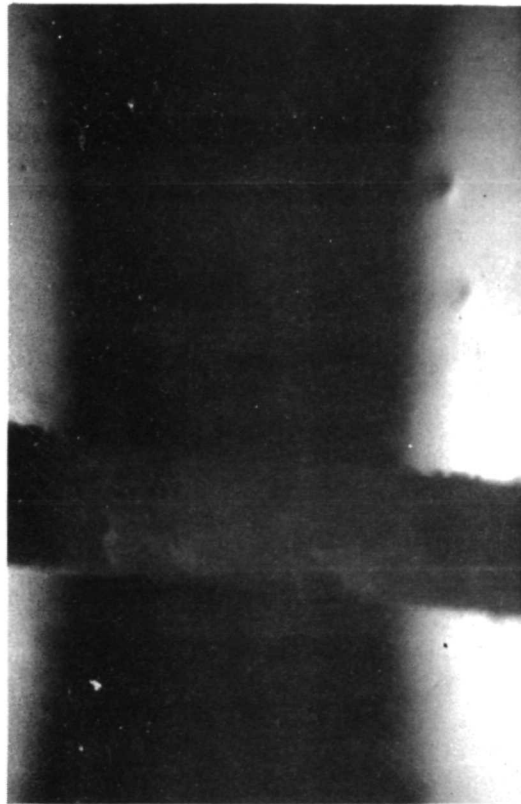
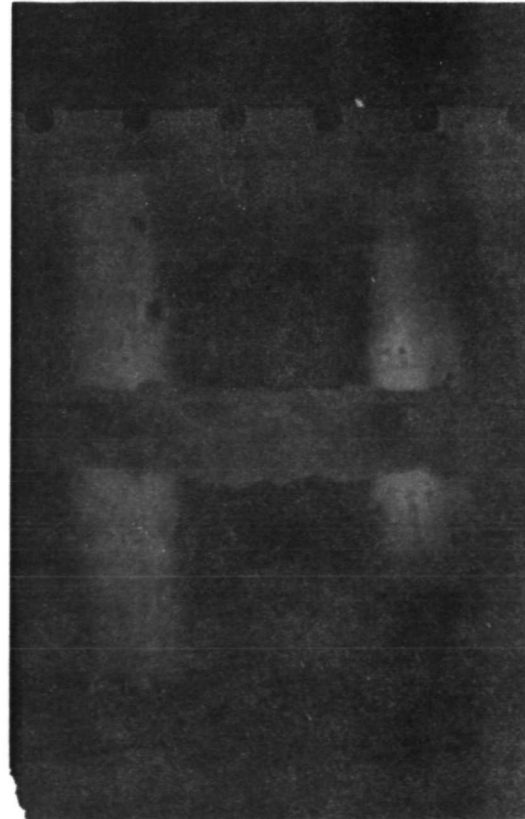
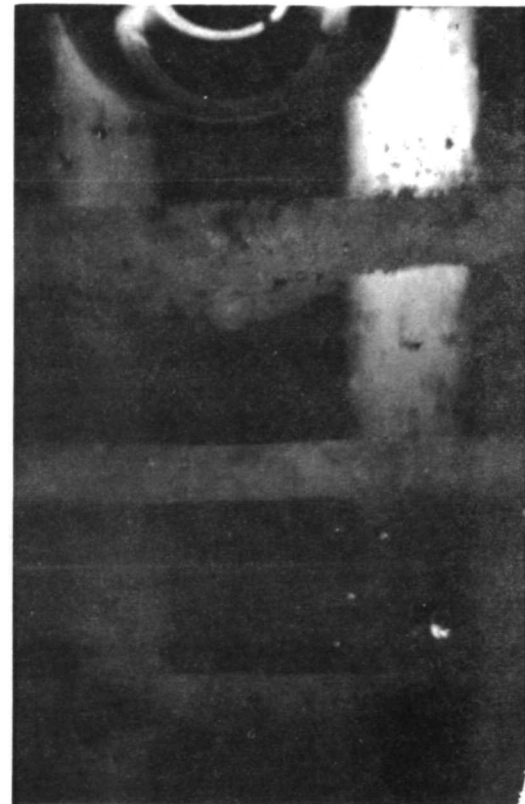
Figure 8. Photographs of Metal Film of Resistors.

(3) Evaluation of Ni-Cr Metal Film. The metal film was examined both with optical microscope and metallograph. The film on both good and bad resistors was normally reflective and of uniform appearance. The edges of the spiral cut in the film in good resistors were more or less regular; however, the bad resistors had film edges which varied from slightly to grossly irregular. Some typical examples comparing the varying degrees of irregularity are shown in figure 8. The initiation of the

NOTE: Edges of cut in film shows varying degrees of irregularities.

film deterioration appears as a "scalloped" effect (photo 2). Erosion normally occurs only in localized areas of the film surface, i.e., not all film edges in a resistor are attacked. Isolated instances of spots of contamination or corrosion were found on the film surfaces (see figure 9), but do not appear to be associated with resistance changes.

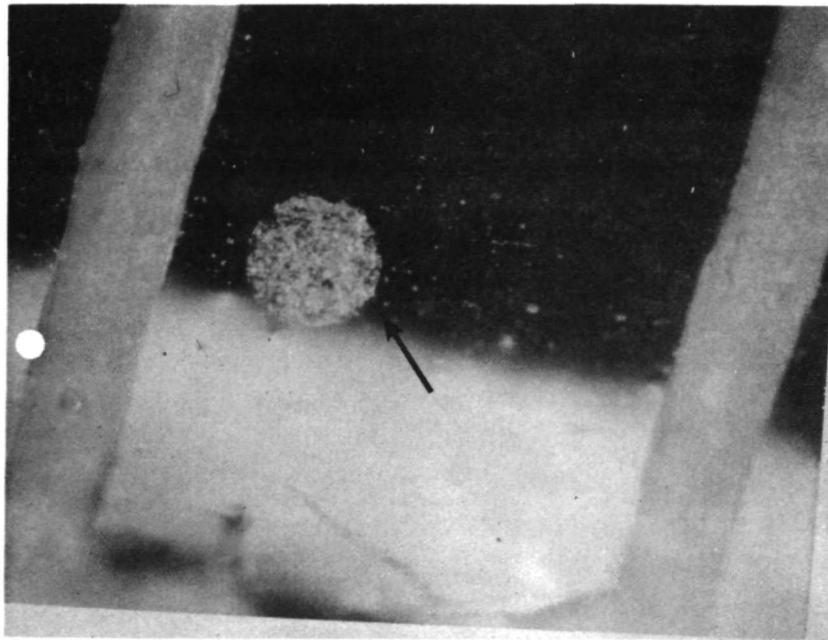
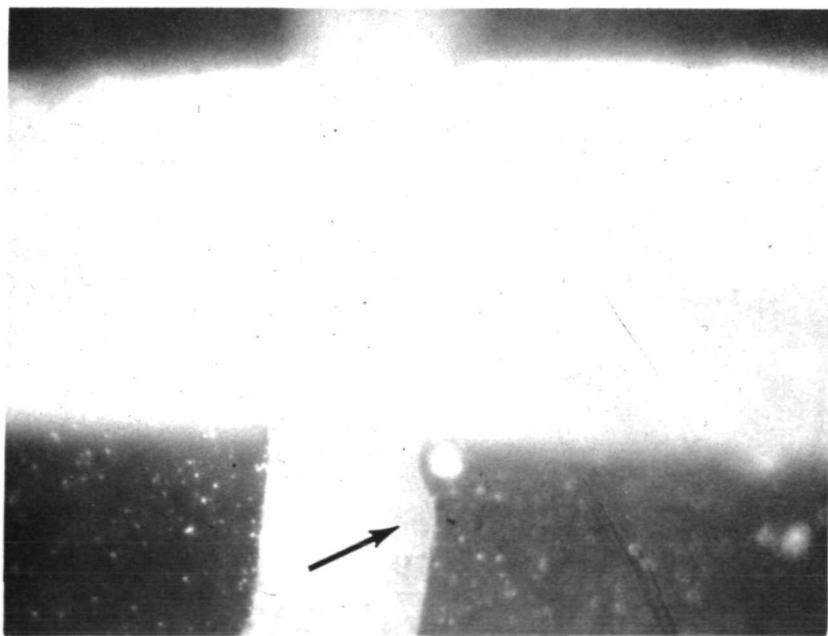
Figure 9. Spots of Contamination/Corrosion in or on Metal Film.

NOTE: Arrows point to deviation at edge of film around spot (photo 2) and the smooth surface of glaze where film was originally.

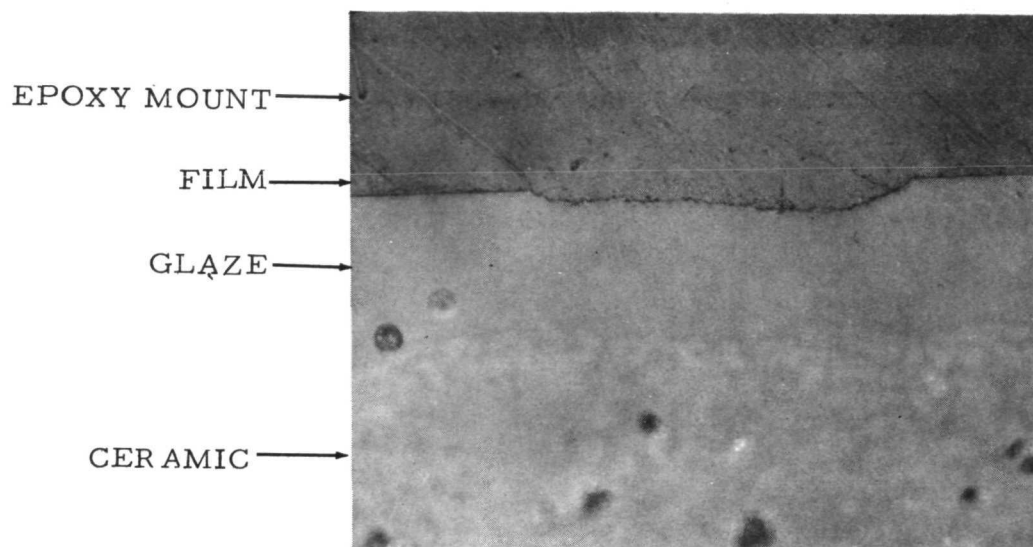
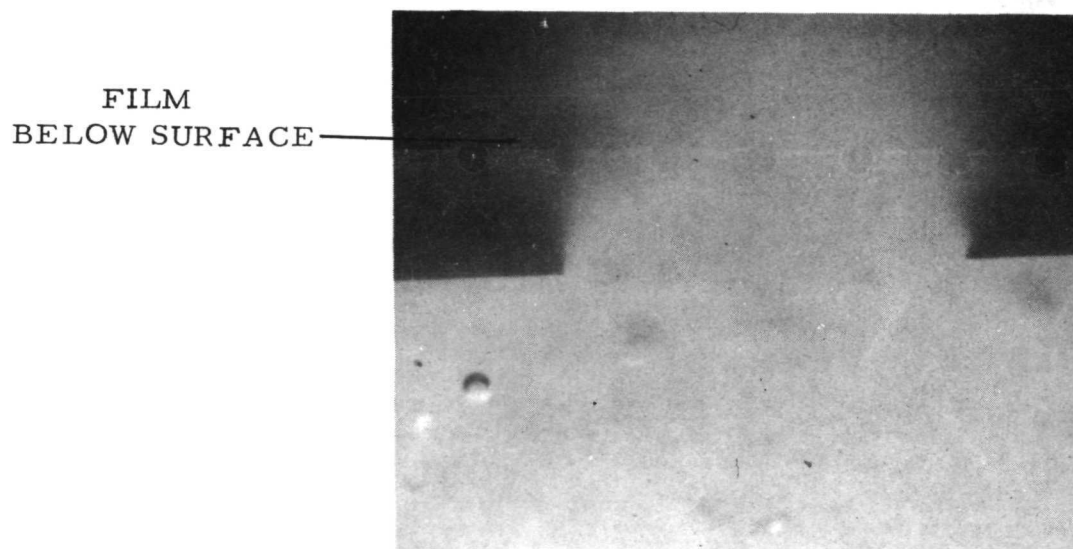
Figure 10. Cross Section of Bad Resistor S/N 219 Through Cut in Film (500X)

The depth of the spiral cut in relation to the thickness of the glaze was evaluated on several resistors. The depth on all examined was less than half the glaze thickness. Figure 10 shows a cut of 0.1 to 0.3 mil on a glaze thickness of 1.5 mil.

Photo 1: Depth of Cut is 0.1 to 0.3 mils

Photo 2: Same area as Photo 1 using polarized light to show film below surface of epoxy.

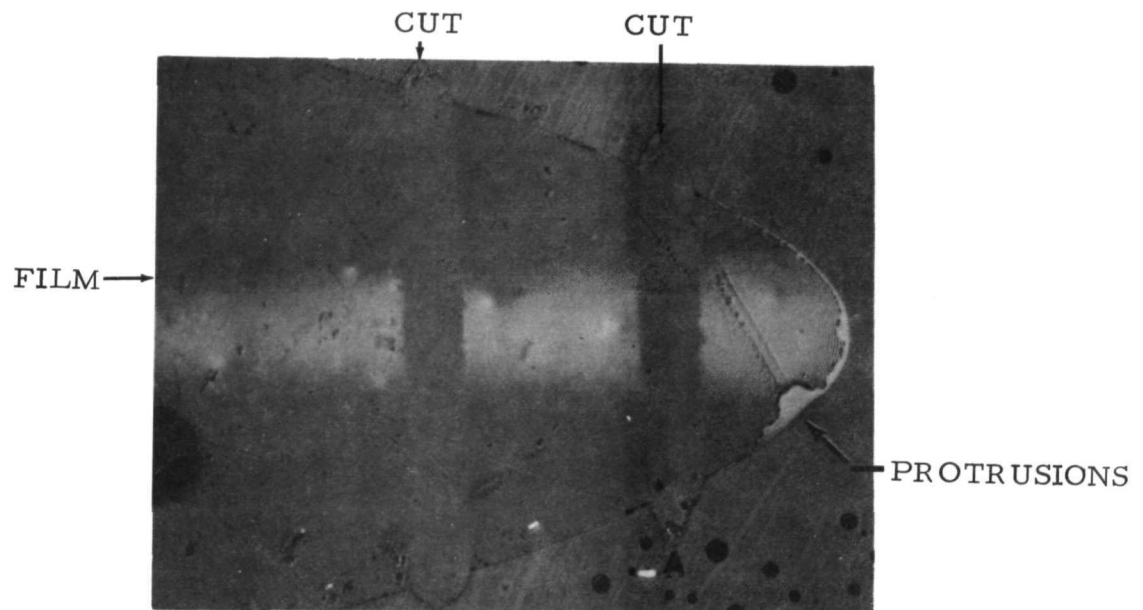
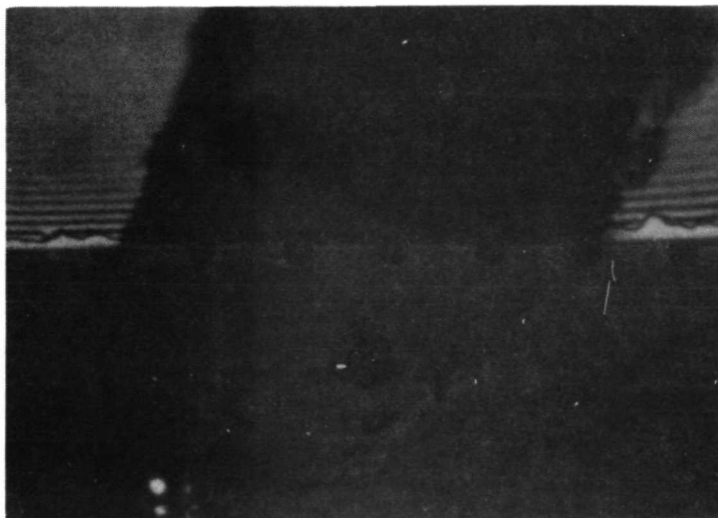
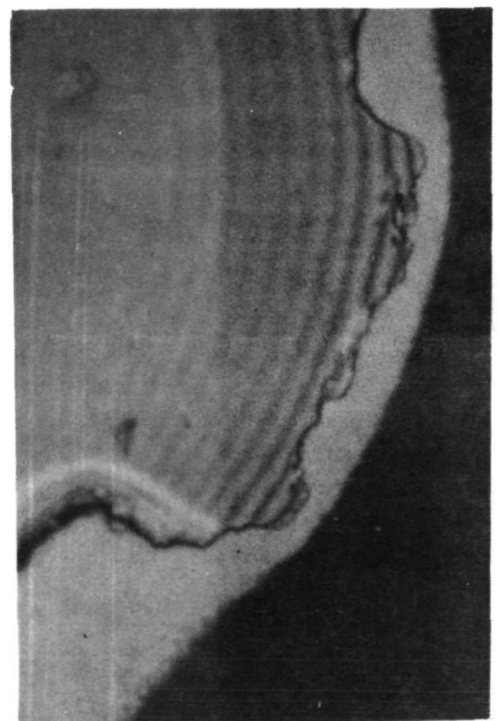
Figure 11. Photomicrographs of Bad Resistor S/N 206

Because of the extreme thinness of the metal film (less than 1000 angstroms) it is not possible to see the true cross section of the film using light microscopy. By sectioning through the film at an angle closely parallel to its surface, however, some indication of the nature of the film can be obtained. Figure 11 shows such a cross section of film of a bad resistor, S/N 206. The film thickness appears irregular, having protrusions (or bumps) which are thick deposits.

Photo 1: 125X Thick Protrusions in Film and Pores in Ceramic Glaze

Photo 2: 1000X Cut in Film of Photo 1 at Position A (Arrow Points to irregular edge on shallower side of cut)

Photo 3: 1000X End of Film in Photo 1. (Shows uneven thickness of resistive film.)

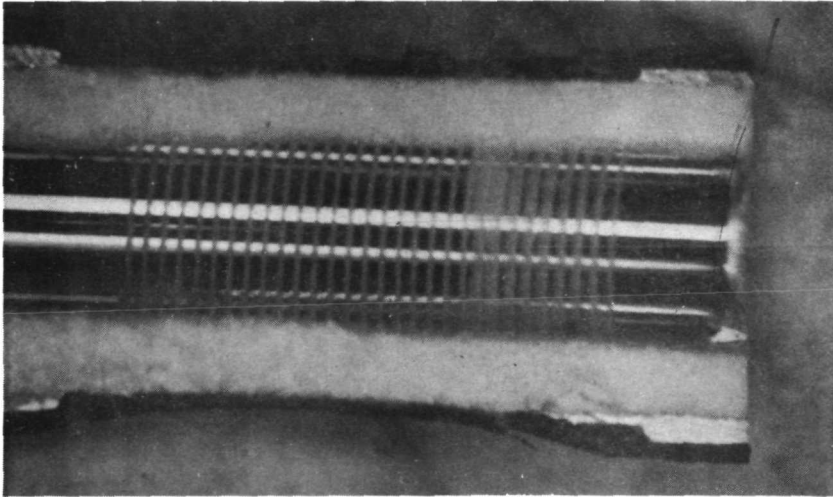
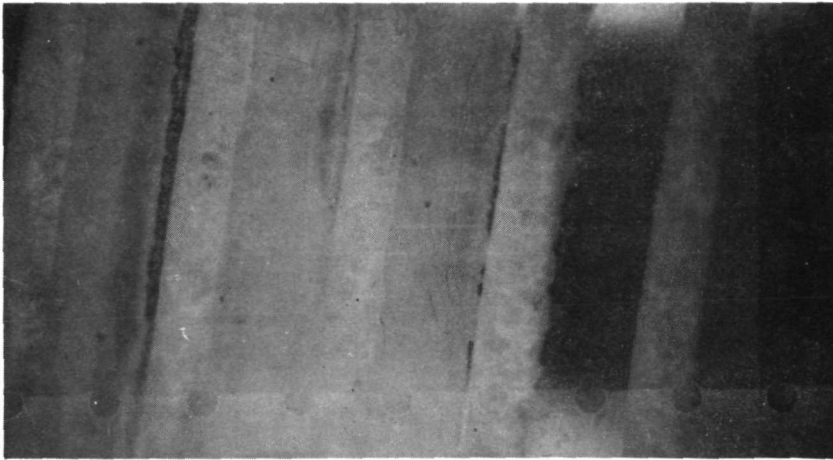
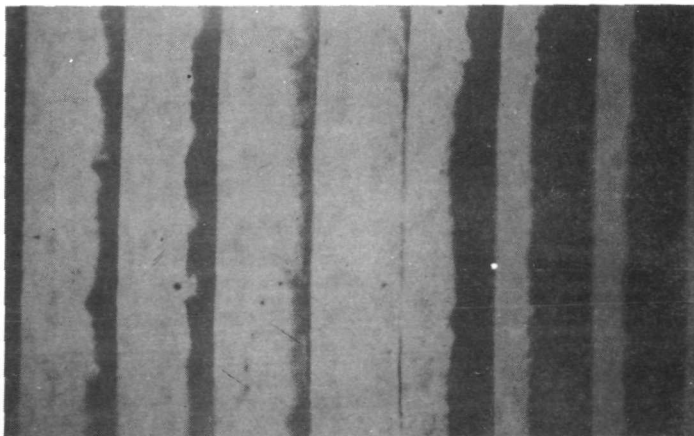
Figure 12. Gross Erosion of Bad Resistor S/N 35 (W)

Two resistors were examined which had "infinite" resistance after burn-in. These were 301k ohm resistors, date coded 7031 and 7032. One resistor, S/N 35 (W), was opened by cutting off each endcap to permit viewing of the film prior to slitting longitudinally. It was observed that a considerable number of edges of the film at the spiral cut was eroded and, as shown in figure 12, one spiral was completely missing in some areas along the circumference. Similar conditions were found in resistor S/N 31 (W) (see figure 13). The cross section of one end of the resistor showed gross voids in the silver coat at the ceramic tube end; and the ceramic retained moisture more readily than other resistors after the post-polishing drying (with compressed air). The porosity of these two resistors, however, does not appear to be significantly greater than others examined.

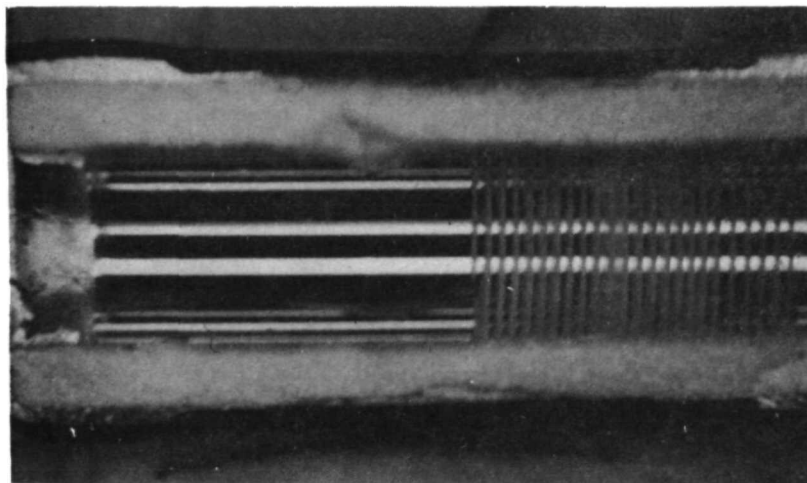
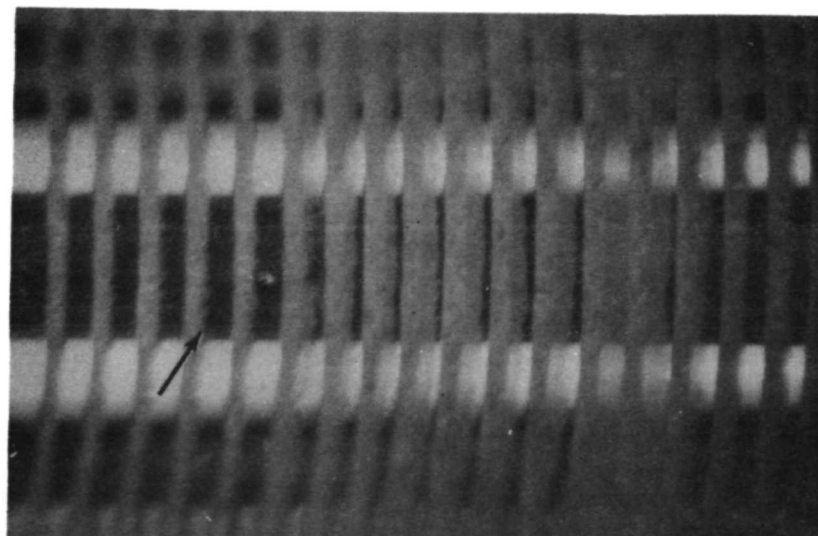
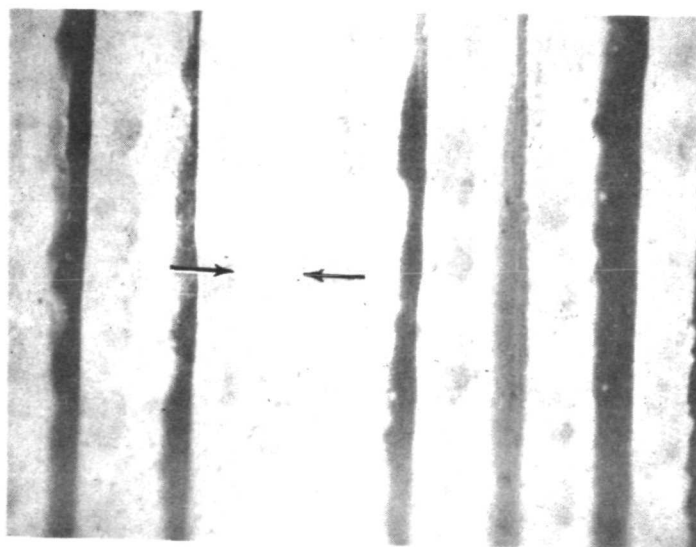
Figure 13. Photographs Showing Erosion of Bad Resistor S/N 31 (W)
(Sheet 1 of 2)

NOTE: Scalloped edges (arrow) on some spiral cuts similar to that shown in figure 8 photo 2.

NOTE: Occurred similar to that of resistor S/N 35 (W) figure 12

Photo 3: 70X (Polarized Light) Complete Erosion of Film
(Area between Arrows)

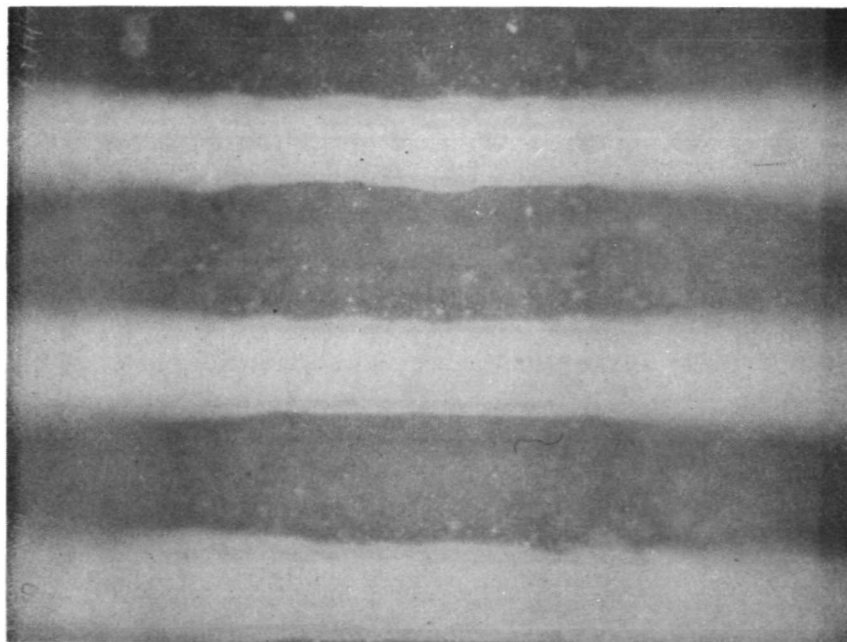
Figure 14. Light Optic Photograph of S/N 27 Resistor

Photo 2: 80X Shows metallization removed from both sides of spiral.

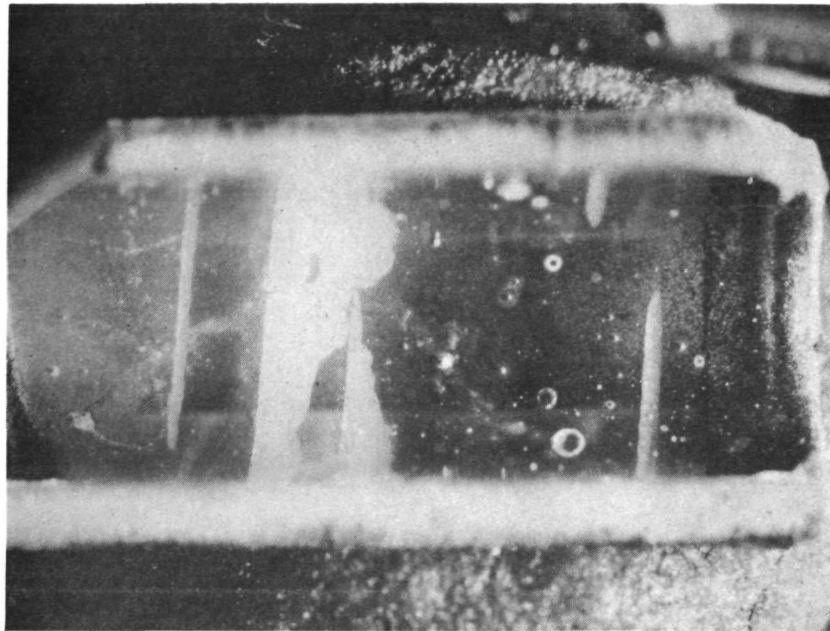
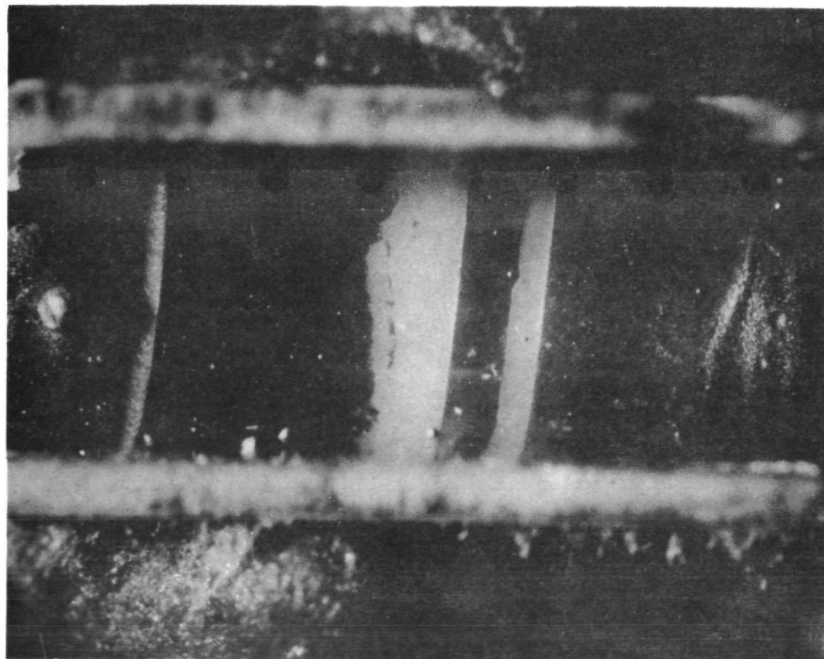
Figure 15. Light Optic Photographs of Resistor S/N 473

Photographs of these resistors are shown in Figures 14 through 16. SEM X-ray analysis of S/N 473 identified potassium, chloride, chromium, nickel, tin, and lead.

NOTE: Shows metallization depletion, numerous solder balls, and residual silver on metallization.

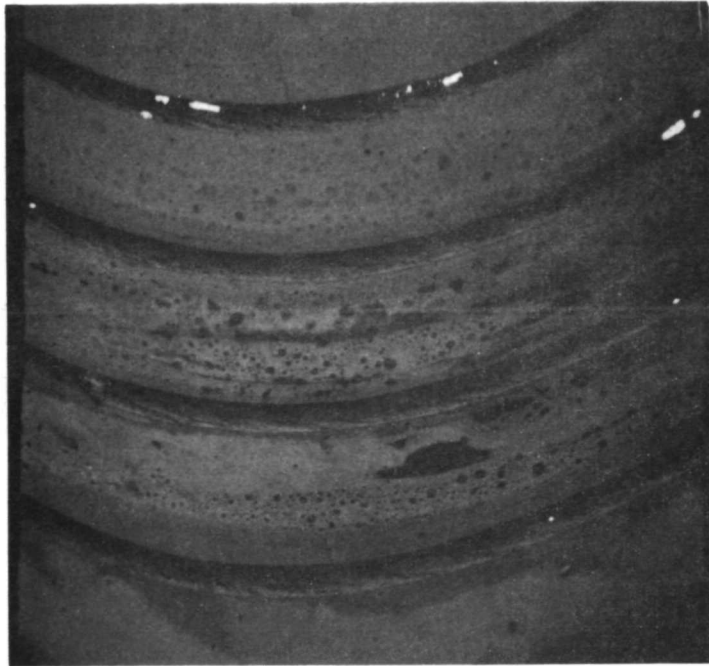
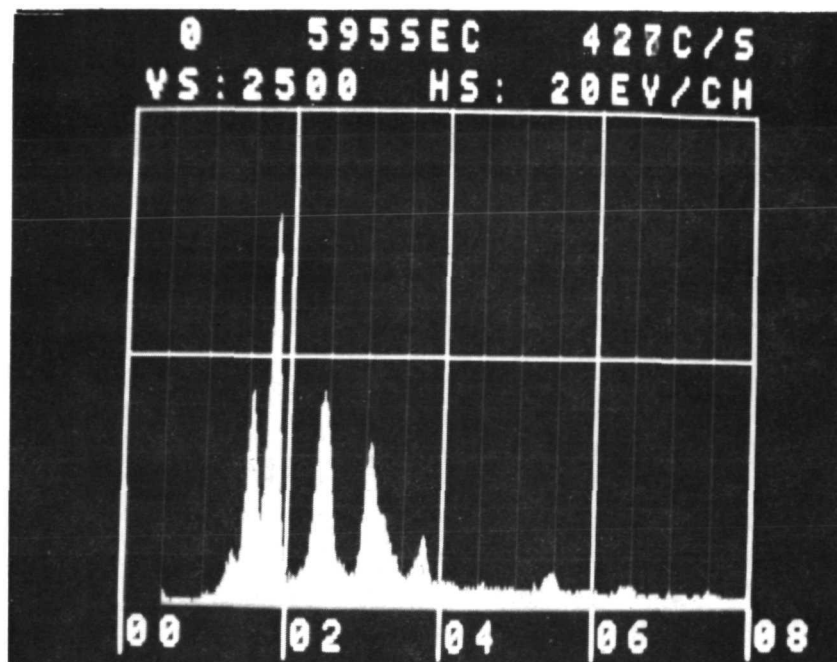
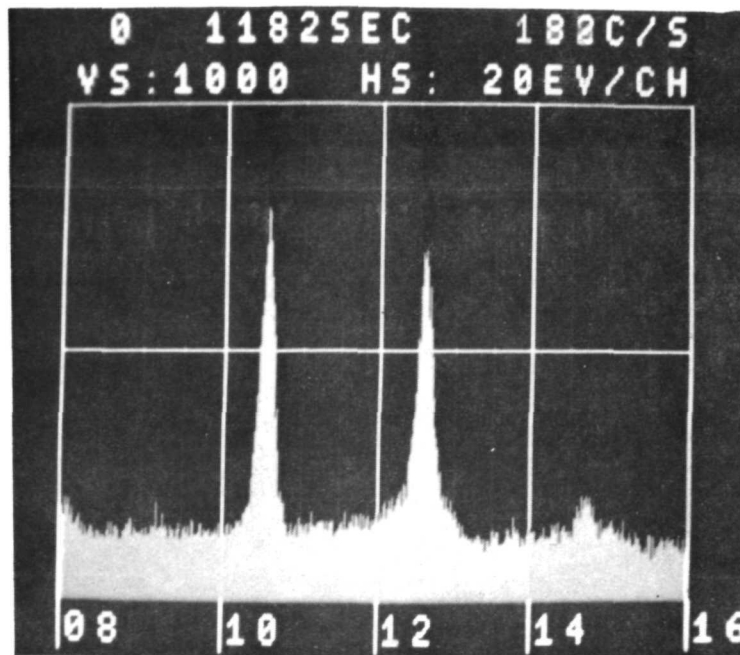
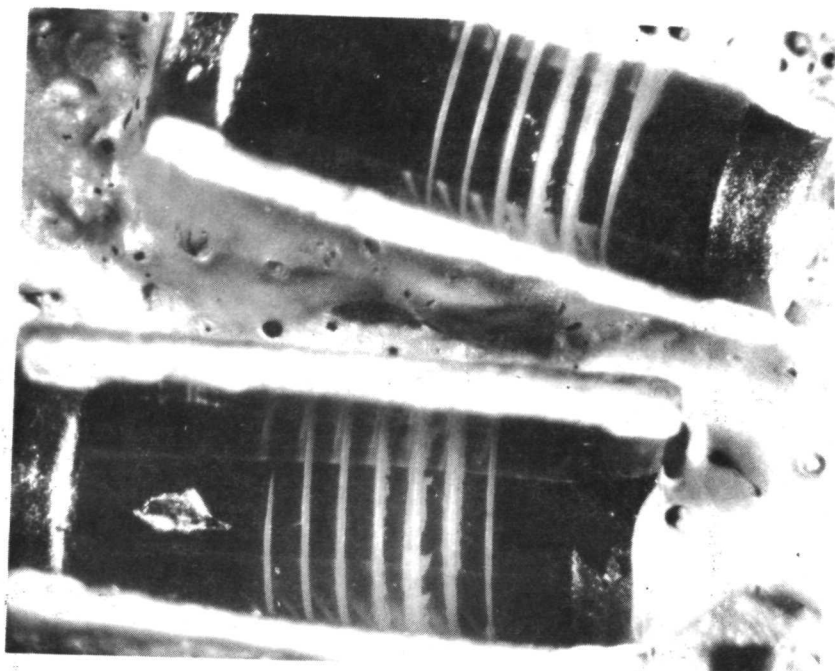
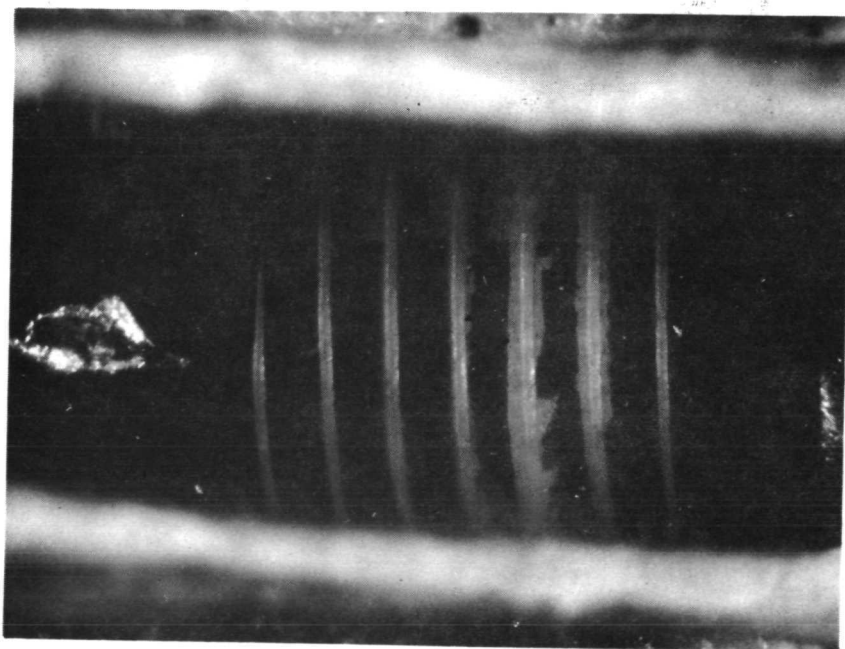
Figure 17. Photographs of Failed Resistor S/N 211 (Sheet 1 of 5)

The remaining two resistors, S/N 64 and S/N 211, had both been removed from nondestructive stress testing after 13 hours at 20 to 30 percent VR and 25 degrees C. Resistor S/N 64 had not drifted, while S/N 211 had drifted approximately four percent from the value of the initial resistance measurement. Figures 17 and 18 shows the results of SEM X-ray analysis of both resistors.

Photo 1: 75X Taken at 2KV (low voltage). Compare with figure 18 Photo 1.

NOTE: Materials cannot be identified on x-ray at this voltage. There appears to be a film over the resistive material.

Photo 3: Lead (Pb) Compare with figure 18 photo 3

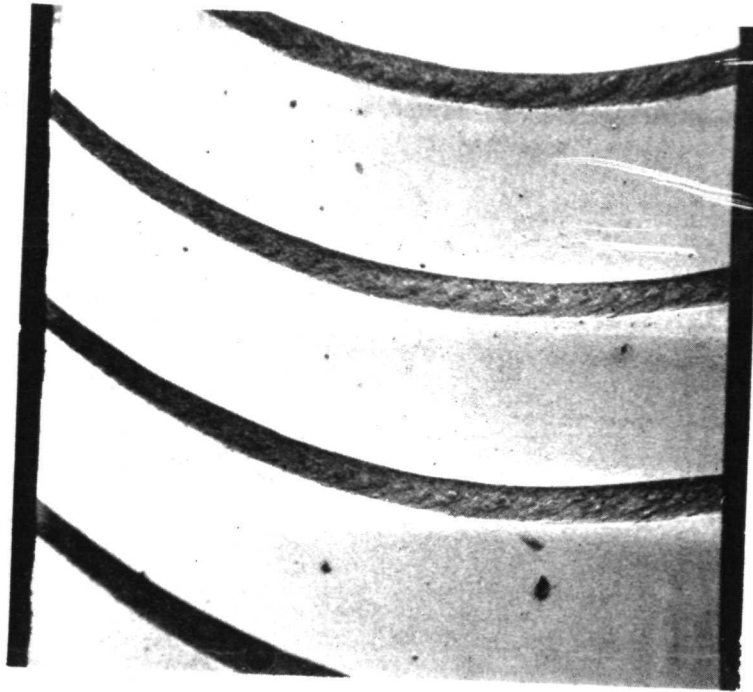
Photo 1: 75X Compare with figure 17 photo 1

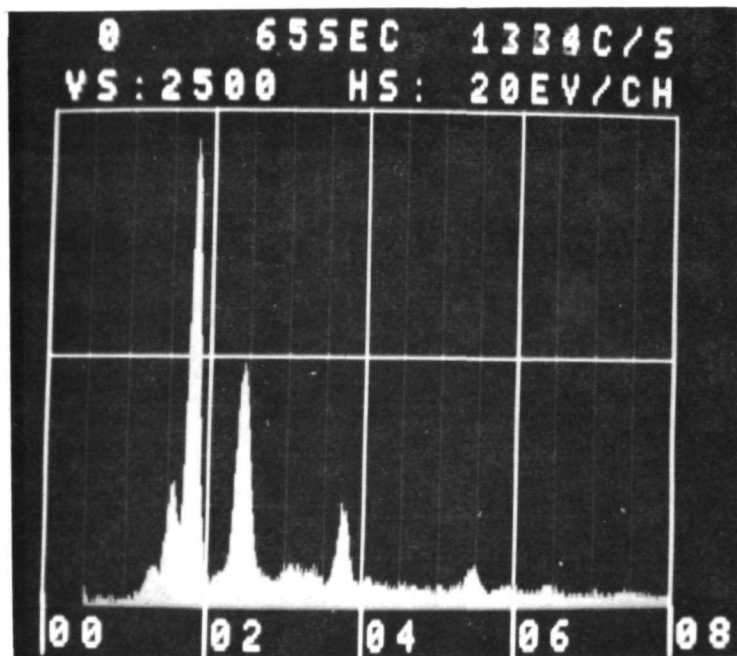
Photo 2: 20KV Compare with figure 17 photo 2.

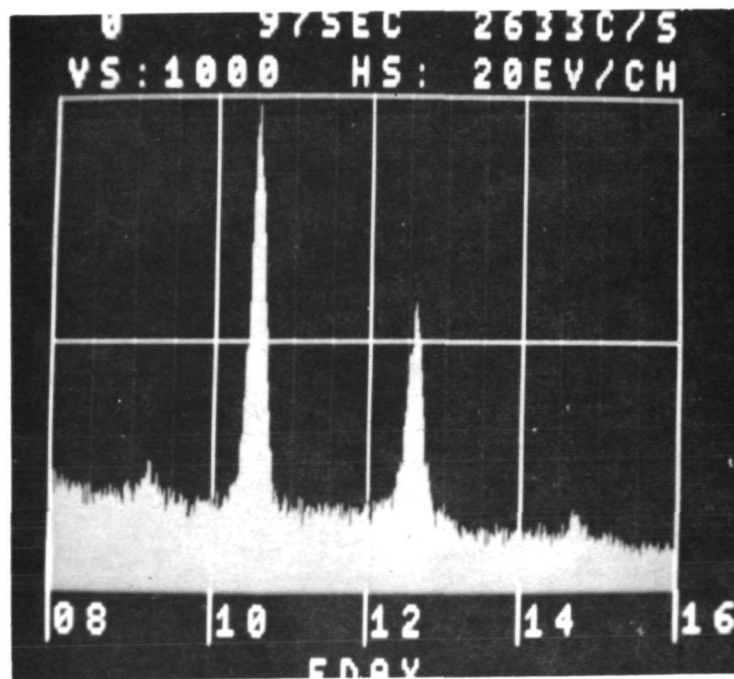
Photo 3: 30KV Compare with figure 17 photo 3.

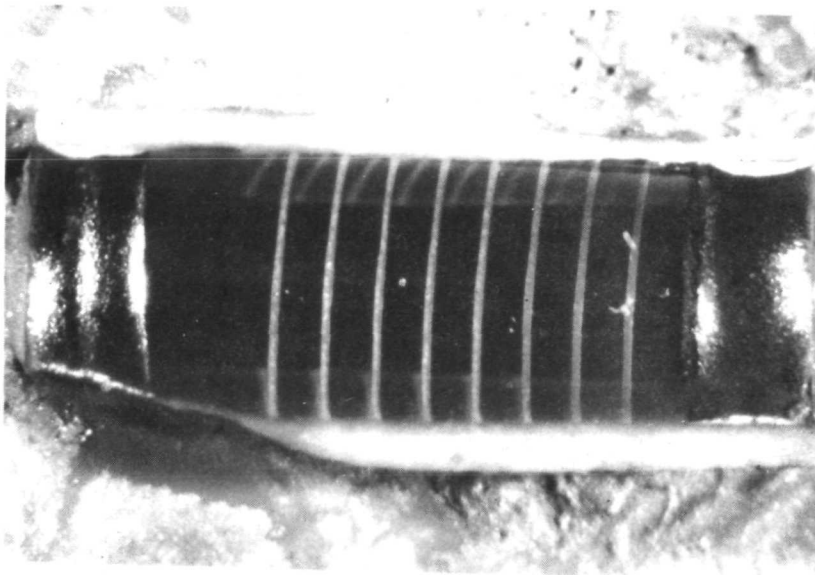
Photo 4: 12X Compare with figure 17 photo 6.

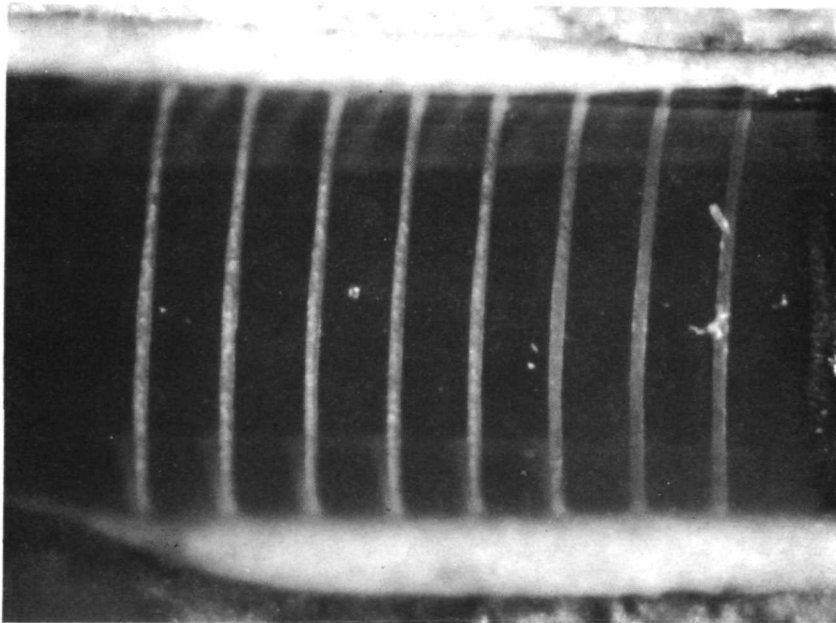
Photo 5: 30X Compare with figure 17 photo 7.

NOTE: The small spots are probably pieces of ceramic caused by the opening process.
